# **A New Technology for Continuous In-Situ Monitoring of Nutrient Levels of Ammonia & Nitrate to Meet NPDES Requirements**

Narragansett Bay Commission

Field's Point Wastewater Treatment Facility

Written for public distribution and reprint  
September 29<sup>th</sup> 1999

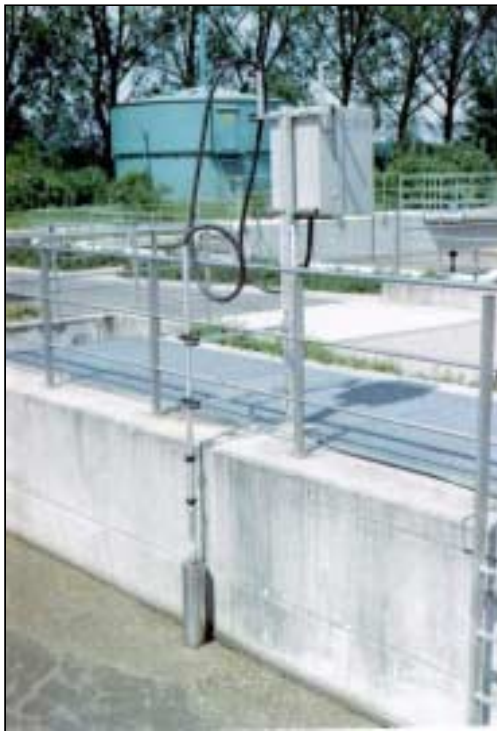
**Figure 1(a)**

Buoy installed in aeration basin

Figure 1(a) & (b) shows a typical Process Buoy installed in an aeration basin.

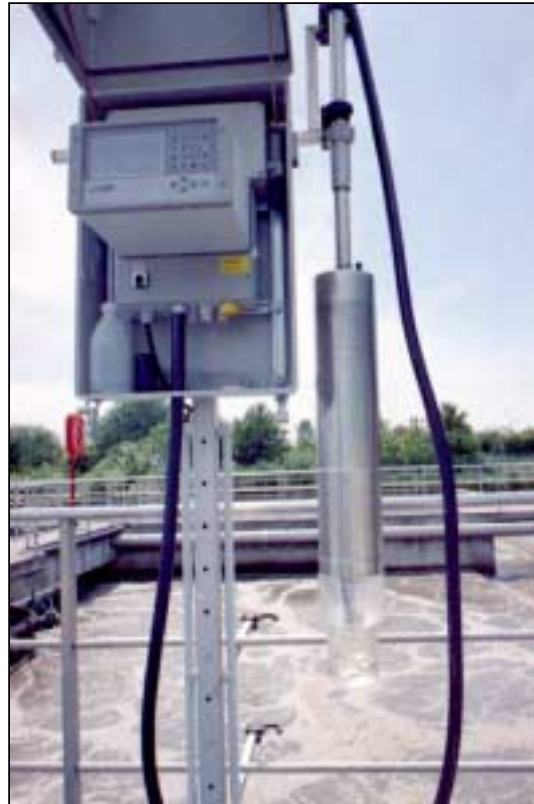
**Figure 1 (b)**

Graphical user interface & microprocessor controller

In addition to controlling the chemical analysis and parameter measurement, the onboard computer with its graphical user interface handles the operational control of all maintenance and test routines. Multitasking capability allows simultaneous handling of special and routine operations. For example, the operator can recall and view or print the stored parameter charts and maintenance data of the last fourteen-(14) days without interrupting the ongoing analysis and data acquisition. The built-in floppy disc drive allows storage of ninety (90) days worth of data on a single diskette. Data can be easily imported into popular spreadsheet programs like Excel.
