Process Buoy PBS1 (NH₄) in a Sewage Treatment Works

Attached please find the success story of a sewage treatment works in the UK using the STIP – Isco process buoy for monitoring the ammonia concentration.

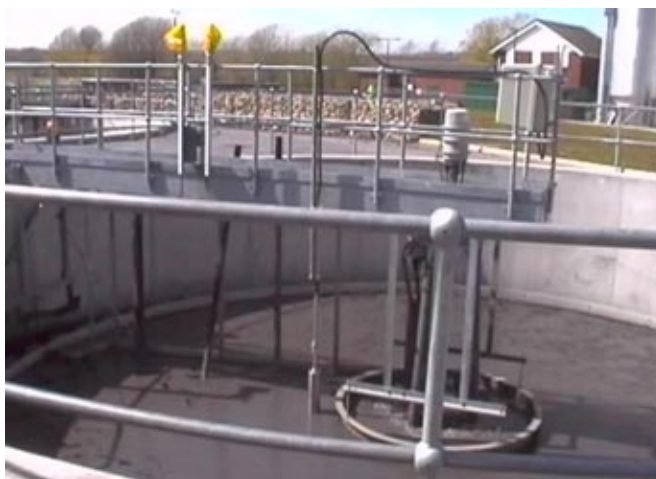
Fig.1 General Installation

Fig 1 shows the electronics housing fastened to the centre end of the rotating bridge handrails, with the wet end sensor suspended from the rails just outside the stilling box.

Due to the nature of the equipment it was possible to locate the monitor on the rotating bridge of the final clarifier, where a power source was readily available.

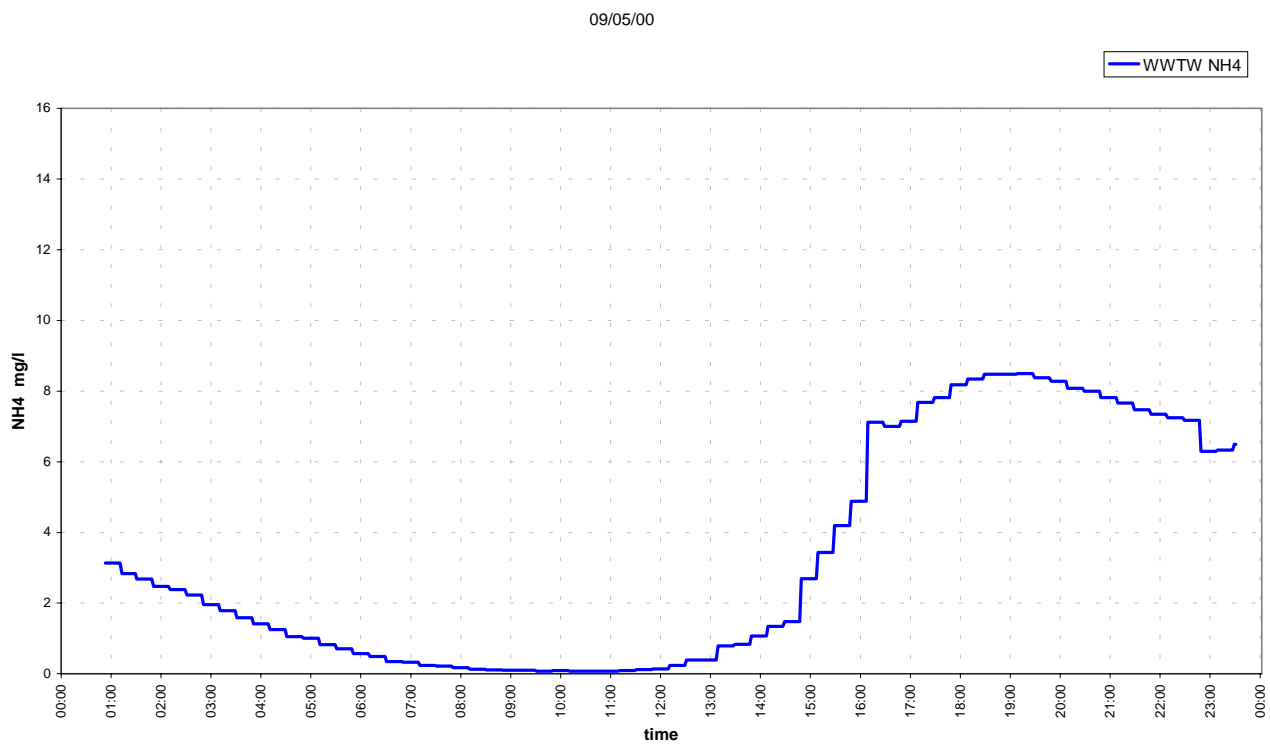
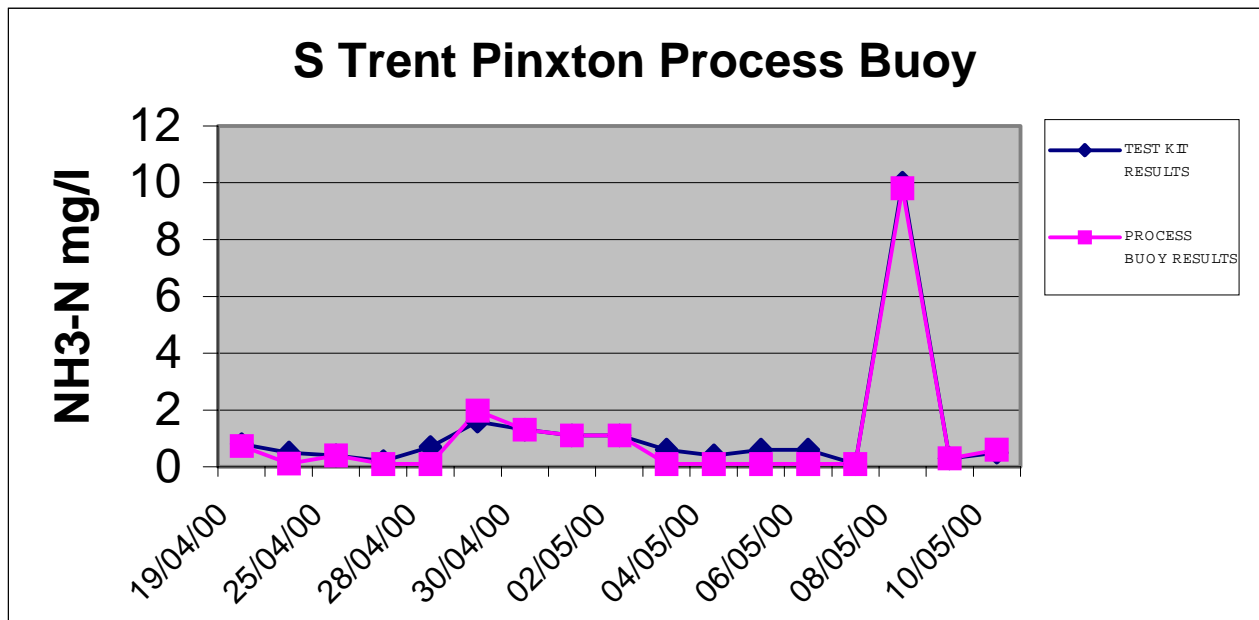
figs 3 – 6

Example graphs of Ammonia – N as recorded by the Isco-Stip process buoy are given in appendix 1, fig 3 – 6

Fig 3 is typical of data obtained over the Bank holiday, no significant elevation of Ammonia occurring, except for a slight diurnal variation peaking around 1 am.

However, later traces e.g. fig6, show significant elevation during night-time. It should be noted that the manual samples did not reflect this, see table 1.

On two occasions, figs 4 & 5, major excursions in the Ammonia concentration occurred, which on investigation were found to be due to power failure and the failure of the aerator auto restart mechanism.

1. No significant event was observed over the Easter Bank Holiday period 2000.
2. Significant elevation of Ammonia concentration sometimes occurs in the final effluent during the night-time hours.

3. The process buoy detected Major Ammonia excursions, caused by power failure.
4. The picture obtained by taking spot samples during the normal working day did not reflect the true quality of discharge, the situation being significantly worse.
