**REPORT**  
to  
**CITY OF KISSIMMEE**  
**DEPARTMENT OF WATER RESOURCES**  
for  
**Demonstration of On-Line Dissolved Oxygen and**  
**Suspended Solids Analyzers**  
at the  
**South Bermuda Water Reclamation Facility**

**December 9, 2002**

**BIOCHEM TECHNOLOGY, INC.**  
**100 ROSS ROAD • SUITE 201**  
**KING OF PRUSSIA, PA 19406**  
**TELEPHONE: 610-768-9360 • FAX: 610-768-9363**

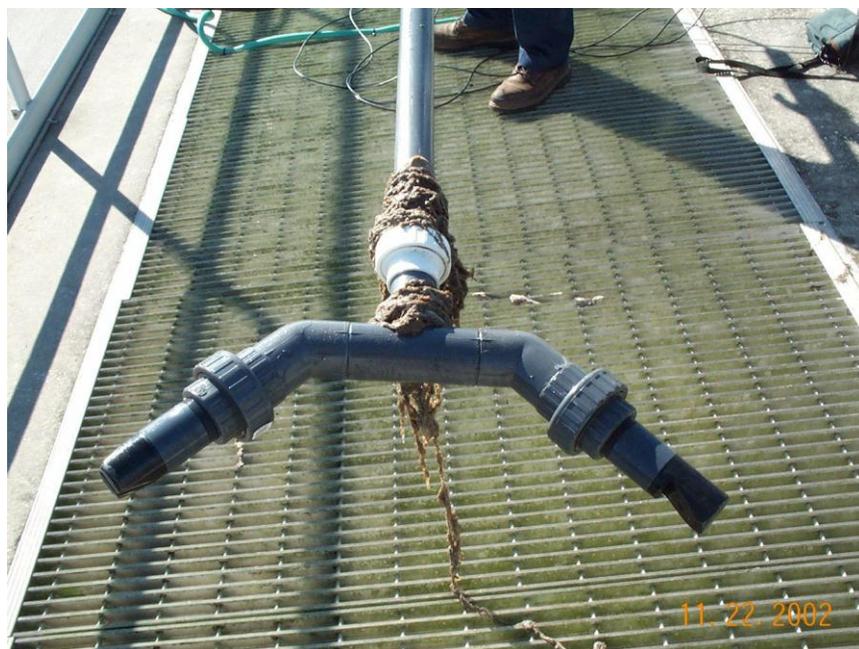
Some difficulty with sensor mounting system hardware was noticed when the sensors were removed for manual cleaning. This maintenance required two people and was somewhat cumbersome. The sensors required removal to remove debris that had accumulated on the assembly (see photo below).

Overall, both of the Insite meters worked well. They each provided reliable operation with consistent and accurate readings despite operating without a cleaning system. The only problems with the unit were related to the probe mounting hardware and a failed solenoid valve.
